CASE STUDY: The History of Water Supply on the Central Coast

APPENDIX 5: Schematic diagram of the rock strata (i.e. stratigraphy) for the selected Mangrove Creek dam site (see page 11).

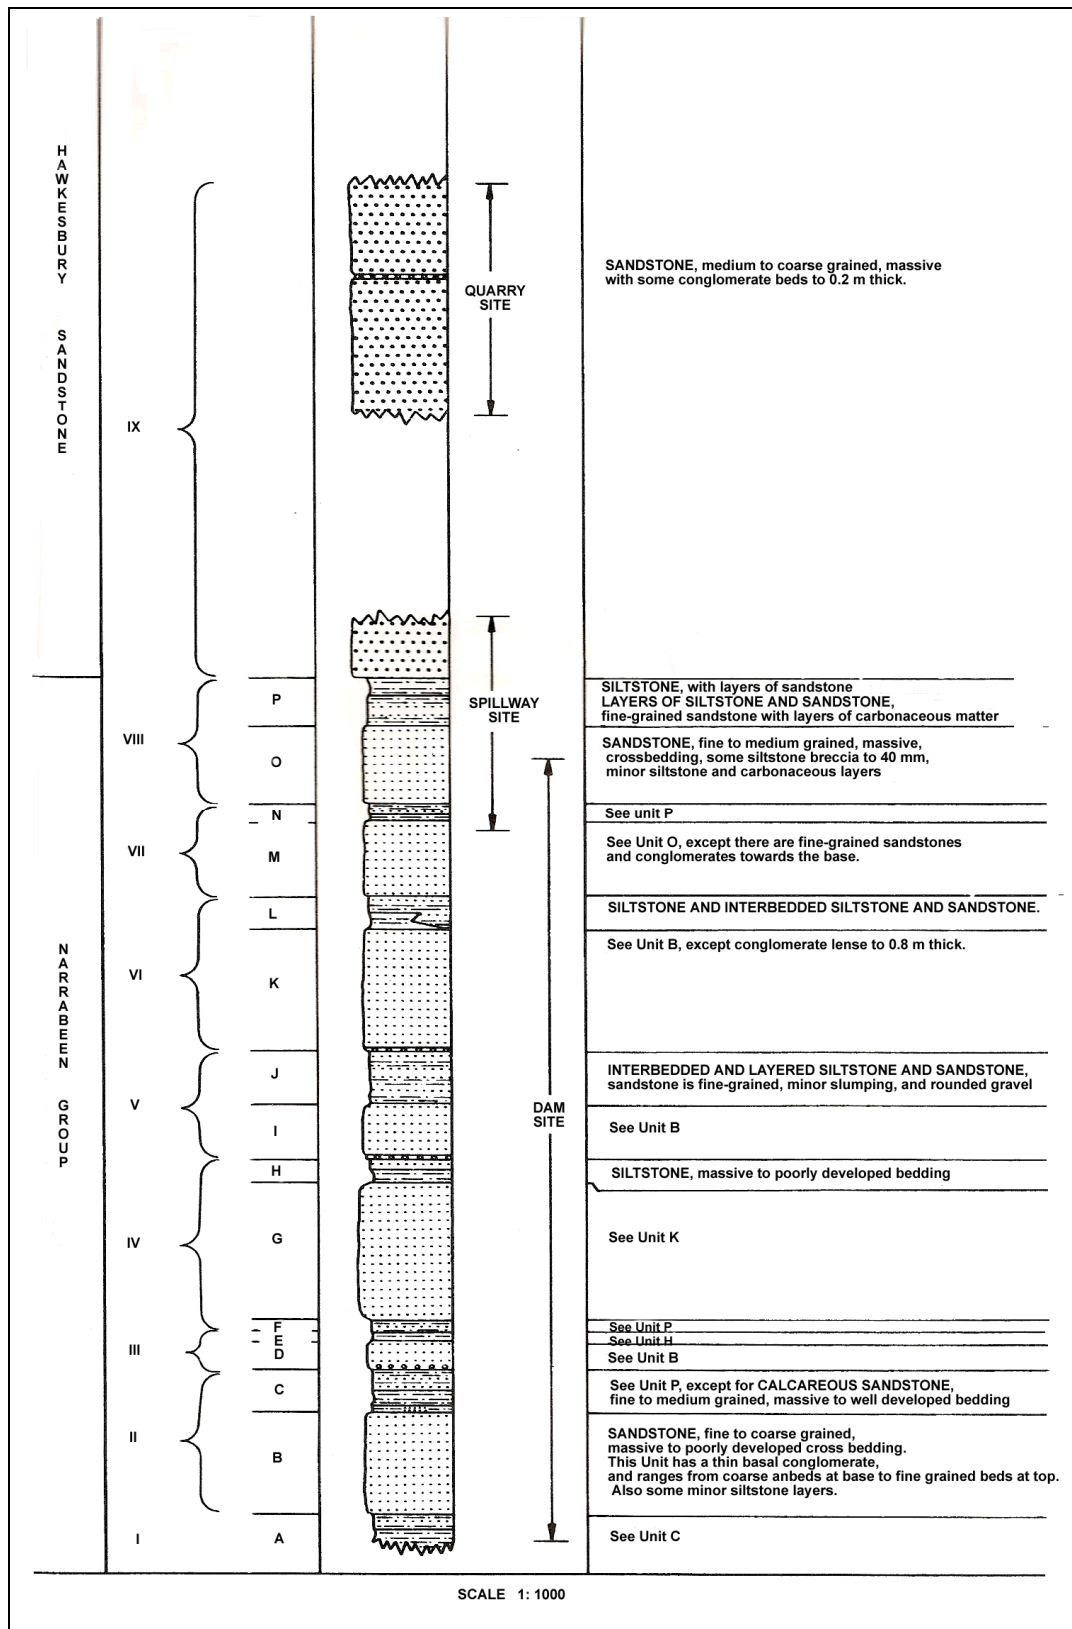
Figure 11: Profile of rock strata at the Mangrove Creek Dam site. ("Mangrove Creek Dam Investigations", Volume 4, Report 1 of "Report on Investigations for Water Supply to the Gosford-Wyong Region", January 1975, Department of Public Works N.S.W., Figure 4 (modified))
